FACILITY COMPLIANCE AUDIT REPORT

Division of Waste Management Solid Waste Section

Date of Audit: 27 July 2011

Wayne's Construction LCID
Morehead City, NC 28557

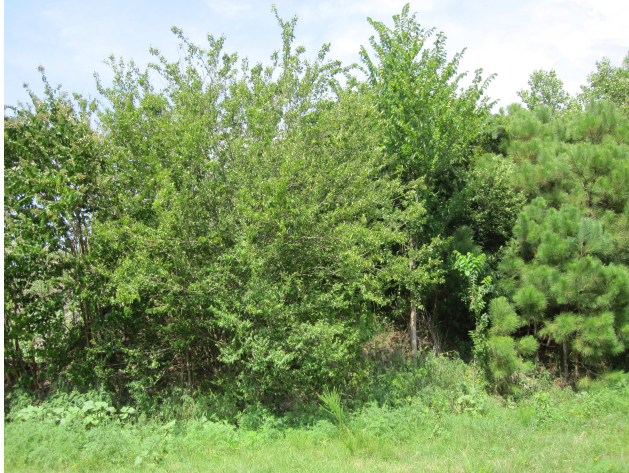
Trees and woody brush needing removal from sideslope

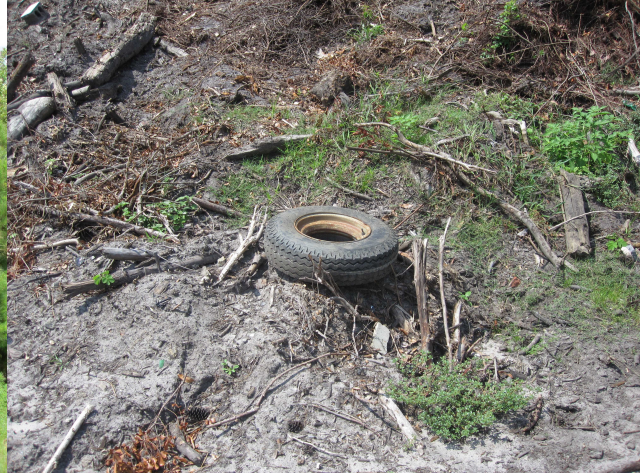
- 6) The waste type being disposed is LCID waste only; and overall no unacceptable waste streams were noted during this audit. However, one tire on a rim was noted at the working face. *Please remove and properly manage this unpermitted waste.

Unpermitted waste at the working face

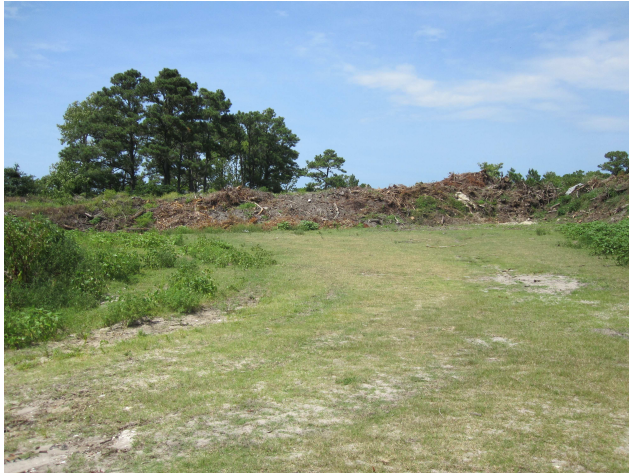
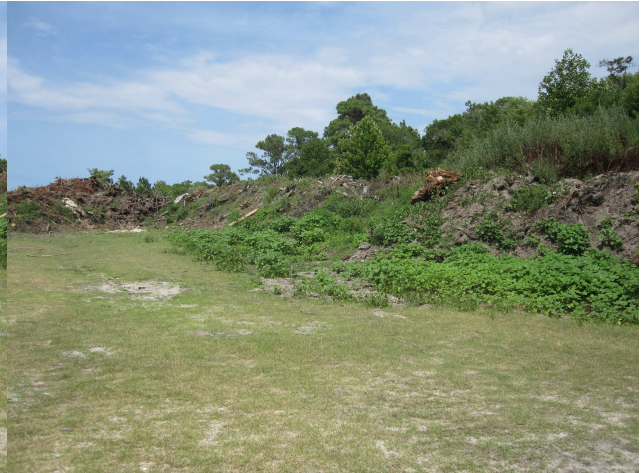
- 7) The active working face needs to be better defined. *Please ensure that one active working face is maintained and that it is covered monthly or when it reaches one acre in size, whichever occurs first.

Active working area
